Case Study: Swagelining of a Cast Iron Water Main

Project: Swage Line a 12" Cast iron water main with 315mm SDR 17.6 Blue PE

Location: Weymouth, Dorset

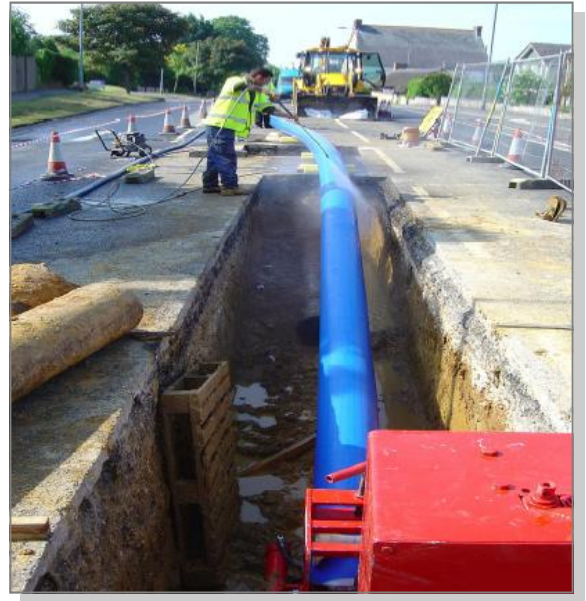
Swagelining is a pipeline rehabilitation technique. The process uses PE pipe which has an outside diameter slightly larger than the inside diameter of the pipe to be lined. The PE pipe is pulled through a die to temporarily reduce its outside diameter. The reduction allows the PE to be easily pulled through the host pipe by a winch. When the pulling force has been disconnected the PE pipe begins to return to its original diameter. However, just before the PE pipe relaxes completely it presses tightly against the inside of the host pipe, eliminating the annular space to form a tight fit liner.
